DEFECTOR RECEPTION CENTER

SUBJECT Milovice Airfield

ENCLOSURE A: Sketch of the Airfield Near Milovice

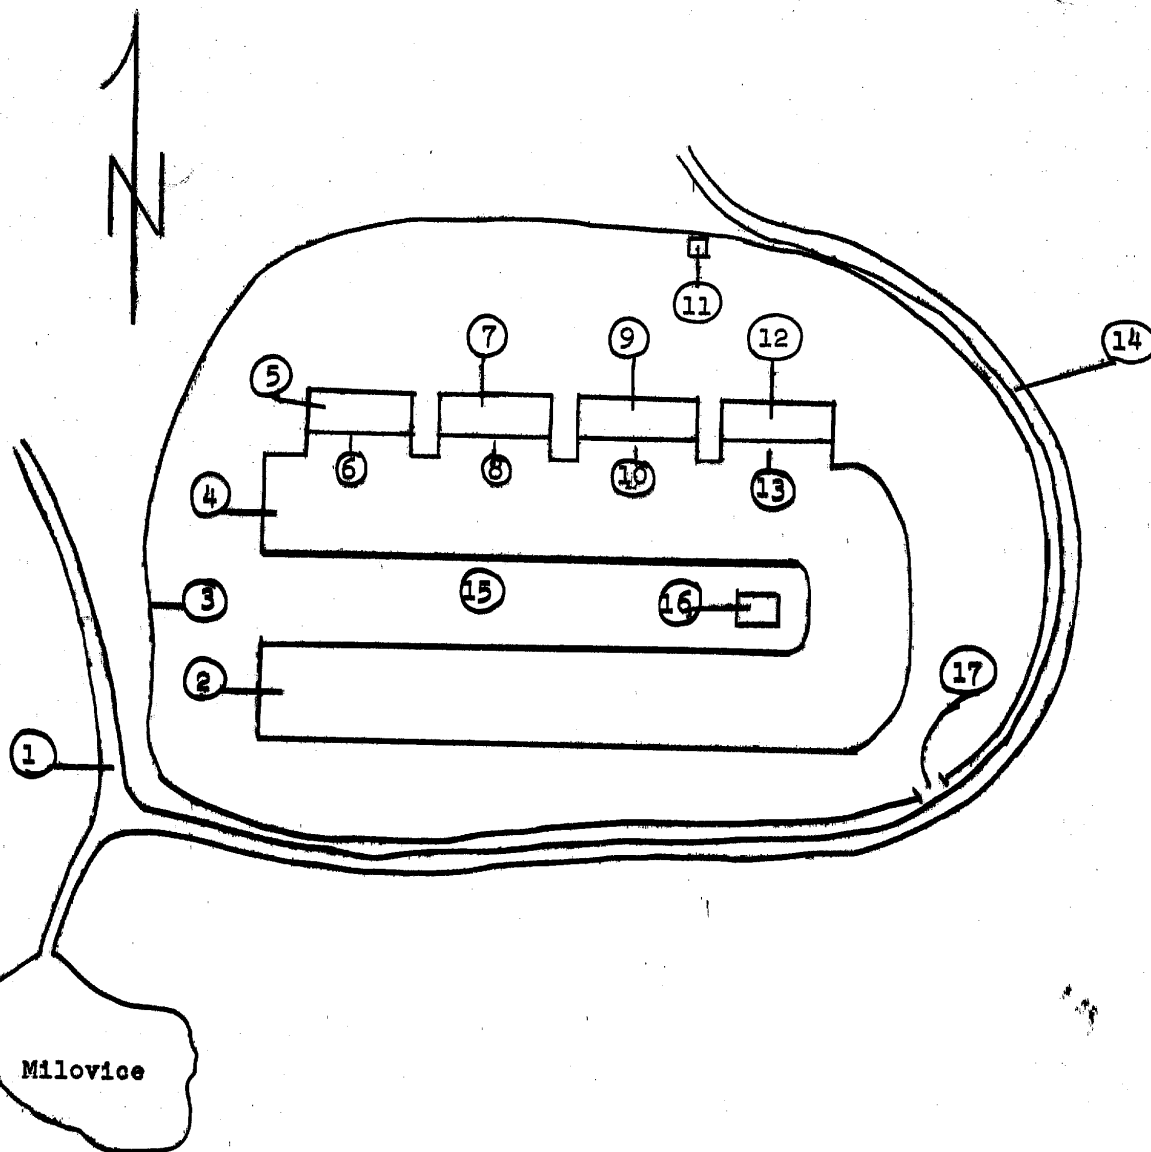
Point # 1. Road: two-lane; dirt; six meters wide; adjacent to and west of the airfield; led from Milovice N 50-14, E 14-54 to Nove Benatky N 50-17, E 14-50.

2. Runway: three kilometers long; 200 m. wide; constructed of concrete sections eight by six meters oriented east to west.

three jet aircraft take off abreast from this runway. The largest aircraft he observed on this runway were a Soviet and a Czechoslovak twin-engine aircraft, identified as the LI-2 and YAK-8 respectively. six or seven aircraft were parked on the east section of the concrete area, at the junction of the two runways.

3. Airfield Perimeter.

4. Runway: this was a taxi-strip despite the fact that it was three kilometers long, 100 m. wide; he had observed jet aircraft making take-offs and landings. This strip was of the same construction as the runway described above Pt. 2.

7, 9, and 12. Hangars: dark green; corrugated tin; 100 x 50 x 4 m.; had gray-green, corrugated tin, curved roofs; also had corrugated tin sliding doors on the side

8, 10, and 13. Aprons: concrete; 60 x 4 m.; connected the hangars with the taxi-strip.

11. Unknown Building: gray, stuccoed-brick; length and width unknown; it was 25 m. high and had a glass dome roof two meters high. Encl. B, Sketch of Glass Dome with Antenna. This building was located 300 m. north of Bozi Dar, a small village near the airfield and 500 m. north of the runway Pt. 2. this was the control tower.

14. Road: two-lane; dirt; six meters wide.

15. Grassy Area: fire hydrants were located here.

16. Building: three-story; gray; stuccoed-brick; 40 x 30 x 12 m.; had a flat, tar-covered roof. Atop this building was a double clothesline antenna.

17. Entrance: the only entrance to the field consisted of a railroad barrier, guarded by one, armed Air Force guard.
